Manhole Inspection Summary

Manhole # S45K__020MH

Insp Date: **8/19/09 9:27 AM**

Location Address: **1816 Aliceanna St**

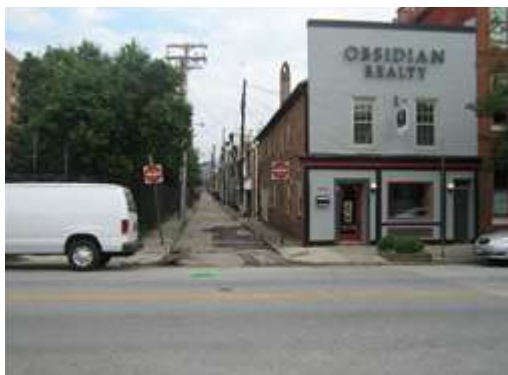
Location View

View facing north

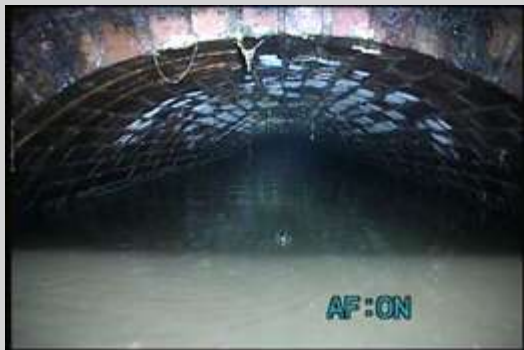
12 O'Clock Outflow

30 in. Circular Gravity Sewer
Pipe Out @ 12 O'Clock

Pipe Height: **32.4** (in.) Rod and Bar (Angled)
Pipe Material: **Unknown** ☐ Pipe Lined
Invert Depth: **15.80** (ft.) Flow Characteristics: **Slow**
Deposits: ☒ None ☐ Mud ☐ Sludge ☐ Debris ☐ Grease
Silt Depth: **0** (in.) Deposits Extent:
Infiltration: **None** Pipe Seal Cond: **Sound**

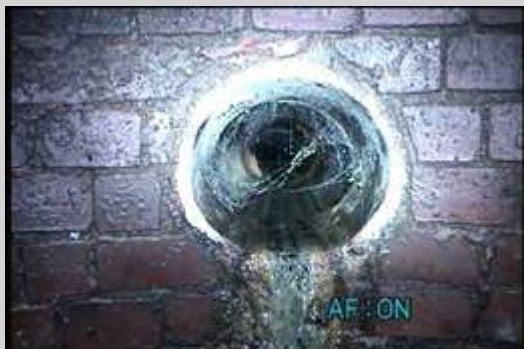
3 O'Clock Inflow

8 in. Circular Gravity Sewer
Pipe In @ 3 O'Clock

Pipe Height: **8.4** (in.) Rod and Bar (Angled)
Pipe Material: **Clay** ☐ Pipe Lined
Invert Depth: **10.00** (ft.) Flow Characteristics: **None**
Deposits: ☒ None ☐ Mud ☐ Sludge ☐ Debris ☐ Grease
Silt Depth: **0** (in.) Deposits Extent:
Infiltration: **None** Pipe Seal Cond: **Sound**

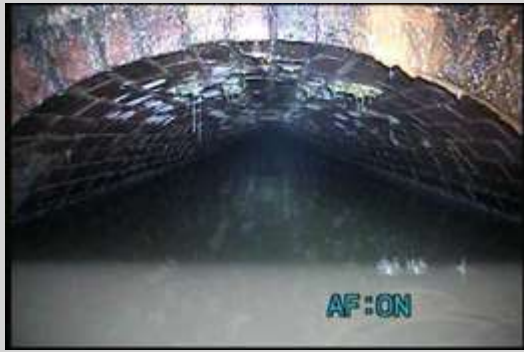
6 O'Clock Inflow

30 in. Circular Gravity Sewer

Pipe In @ 6 O'Clock

Pipe Height: **31.2** (in.) Rod and Bar (Angled)

Pipe Material: **Unknown** ☐ Pipe Lined

Invert Depth: **15.68** (ft.) Flow Characteristics: **Slow**

Infiltration: **None** Pipe Seal Cond: **Sound**

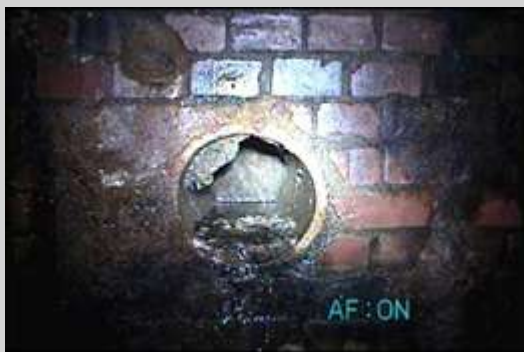
9 O'Clock Inflow

8 in. Circular Gravity Sewer

Pipe In @ 9 O'Clock

Pipe Height: **8.4** (in.) Rod and Bar (Angled)

Pipe Material: **Unknown** ☐ Pipe Lined

Infiltration: **None** Pipe Seal Cond: **Sound**
